# There's 'Good News' and then there's 'BadNews'...

But to see the great decliner in the apex of the roof of the old Union Chapel in Ampthill, in Bedfordshire, now the Baptist Church, really does require you to look up; it is high in the apex of the roof above a plaque declaring the date of building and that of its extension. The whole mount has been re-bricked using engineering bricks rather than ones of the original colour.

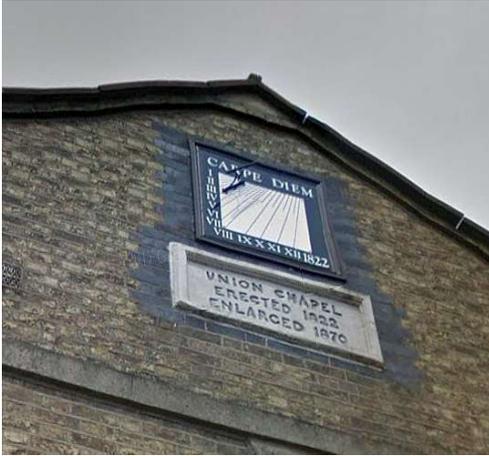
The discovery of a rarely seen great declining dial therefore is rightly good news, as is the fact that clearly the dial in question has recently been carefully re-painted.

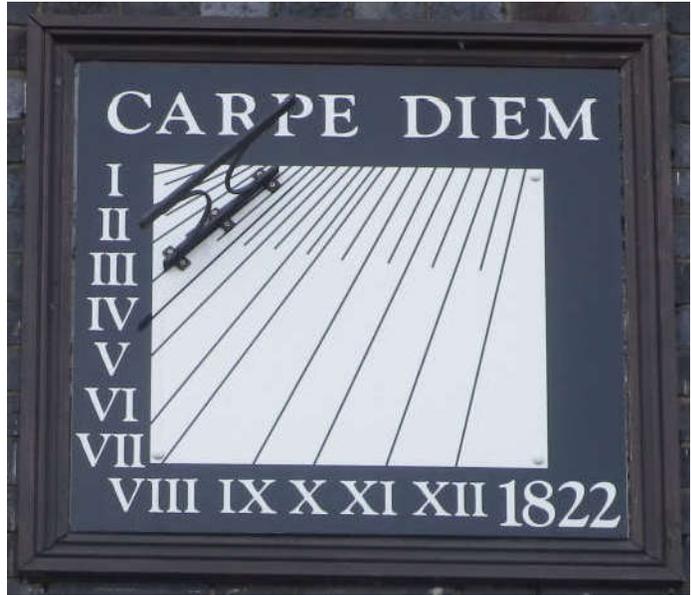
So, what then might be the bad news in the heading to this page? Well, it is simply that the delineation is seriously incorrect! Just look at a close up of the dial face.

The dial faces approximately 80 degrees East of South and is at 52.03 degrees N in Latitude so it should display the local meridian's solar time between something like the hours of 03:45am and 12:45pm.

So how come the dial is painted without a vertical noon line and shows a line for 01:00 am? Just as worrying, is how can it be that the drawn hour lines are at such strange angular spacings and the gnomon does not lie along the expected time line of 06:32 am?

The answer almost certainly lies in 'Restoration Drift', the way in which successive repaints made on top of lost detail simply do not follow the correct delineation.

How sad that the opportunity for repainting did not include consideration of the dial's proper operation.

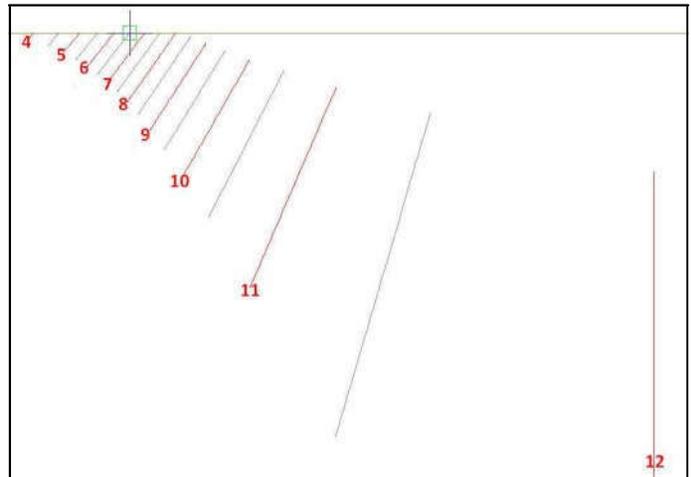
The diagram below roughly shows the correct layout of the hour and half hour lines for this dial and the cross on it indicates the correct position of the gnomon.
