Restoration of the Sundial at All Saints' Church in Isleworth

It is always pleasant to be able to record the restoration of a worn dial but it is especially rewarding when the worn dial had previously been incorrectly delineated and wrongly restored. Such a restoration offers the chance to put things right. This was recently the case with the sundial on All Saints' Church in Isleworth.

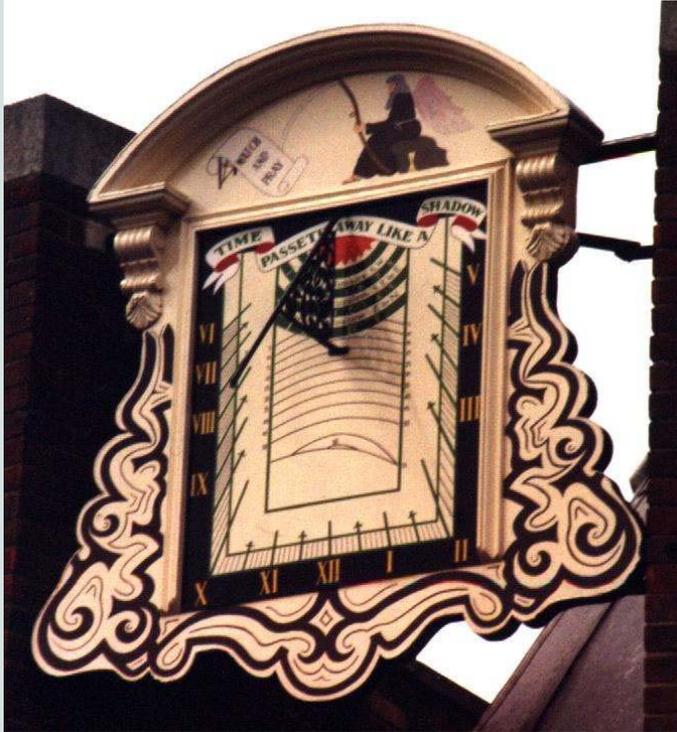
Figure 1: The Isleworth dial soon after its previous restoration in 1999.

The dial's delineation was completely reworked and checked and the final basic layout transferred to a CAD drawing package so that a full sized cartoon could be produced. A new marine ply dial plate was constructed, sealed and painted on both sides with a white gloss exterior grade paint. The design was then pricked through the cartoon onto it. In view of the extensive artwork that had to be reproduced on this dial all fonts, numeric styles and the hour line markers were left to be brought into balance by the signwriter who faithfully used the same colours, and styles that were known to have been used in past versions of the dial. The scroll work on the backplate was not copied from the 1999 design shown in Figure 1 since

all known earlier restorations were found to have much more floral scrolling. This floral scrolling was copied as far as was possible using the descriptions and the B&W images available in the church's archive..

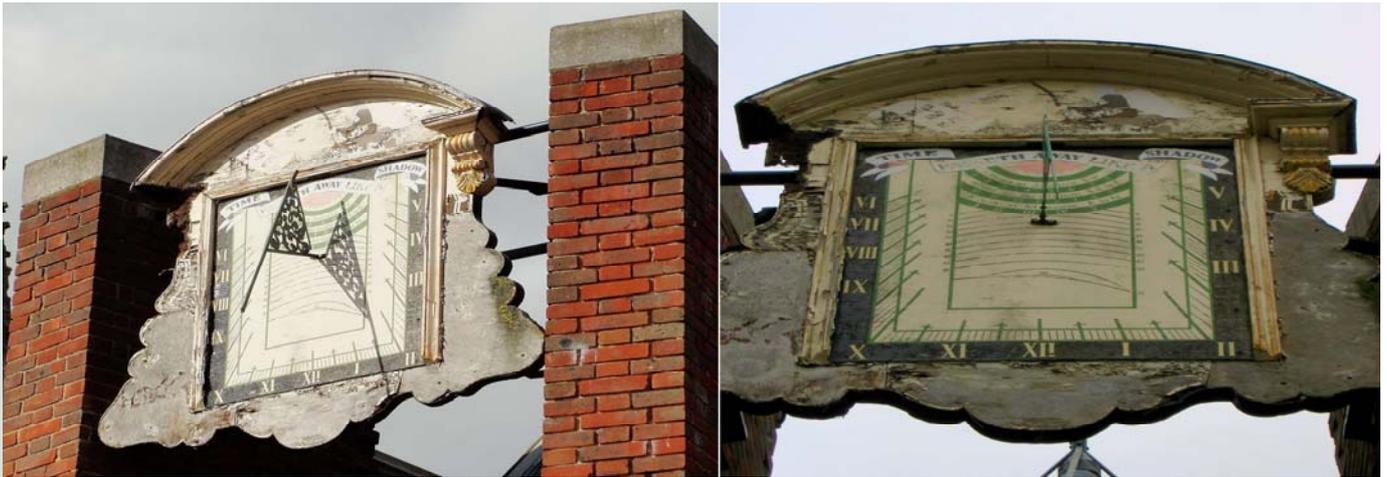
By 2010 the dial had seriously deteriorated. The twin views of Figure 2 show that by then the gnomon was partially detached and in imminent danger of falling onto passing pedestrians, one wooden corbel had fallen away and the fabric of the dial was in an advanced state of decay. Like most Church of England churches, All Saints' is exempt from most listed building control. Alteration, restoration and change are instead regulated by the complicated and quite onerous process of licensing necessary works by means of a *Faculty Jurisdiction*. A 'Faculty' was therefore duly applied for from the Consistory Court of the Diocese. In view of the length of this procedure, this was done prior to any detailed discussions over the manner of restoration. As a consequence all subsequent restoration works had to follow the existing design and materials and longer life options using more modern materi-

Figure 2: The 1999 dial as it was in 2013 just before restoration

Royal Warrant holders Charles Perry Restorations of St Albans won the contract to perform the work. Owing to the risk that the gnomon might soon fall the dial was swiftly removed from its position, well before any consideration could be given to the matter of the work needed to remedy its many defects of delineation.

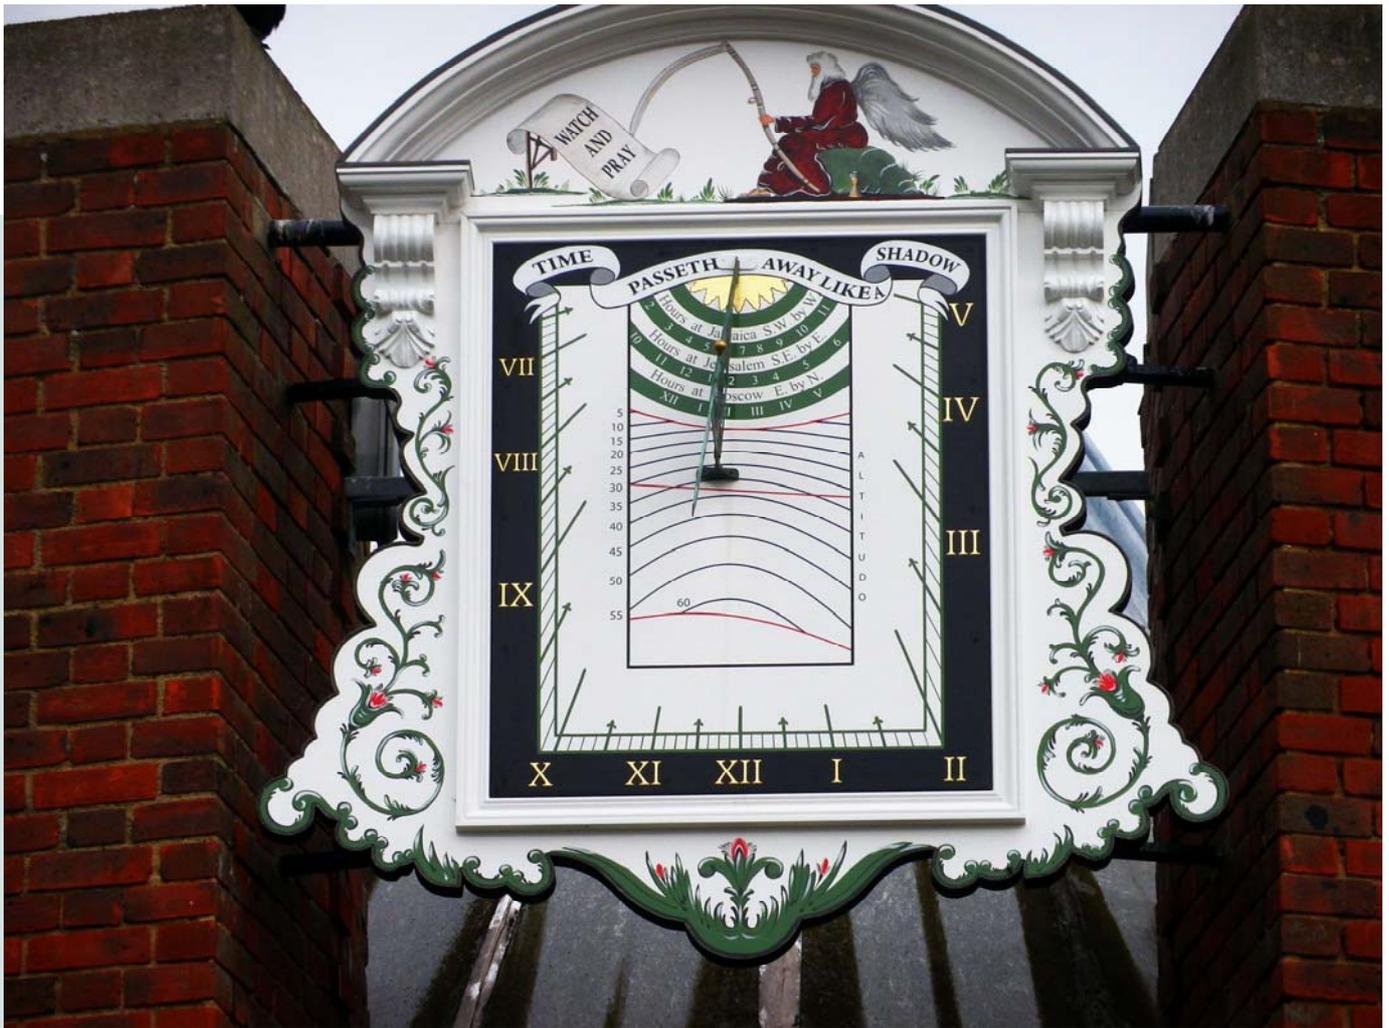
Figure 4: The dial as restored and installed

The original dial as removed had been constructed from a single backing piece of 2½ inch thick ply. Its weight had proved to be a major obstacle during removal of the dial from the tower and it was decided that the replacement should be made in two lap jointed halves of marine ply that could be simply bolted together after raising them in place. This was achieved using concealed fittings. The reduced sizes of the component parts also made it easier for the dial to be transported to the signwriter for all of this work. He had recently retired to Cornwall but had been persuaded to come out of retirement for this one further project.

As much as possible of the arched pediment and the remaining damaged corbel was retained by letting in new wood where appropriate and a completely new west corbel was carved to replace that which had been lost.

Once all of the painting had been completed, the scalloped edges of the backing together with the tops and horizontal inner surfaces of the pediment were covered in lead and the gnomon, together with its new spherical nodus was fitted.

Before being taken to site, the fully assembled dial was set in a frame and oriented and slightly tilted to allow it to be fully checked at ground level in St Albans. The test showed an excellent performance. Following this the dial was transported, assembled and installed at All Saints'. Installation to a precise alignment at such a height – and with four separate mountings each with links proved not to be easy. It was aligned as far as was possible given available sunshine. This was done against a pre-calculated table of the solar time that should be indicated for any clock time during the day. Figure 4 shows the new dial in place on the tower.
