The Mystery of San Marco's Noon Mark

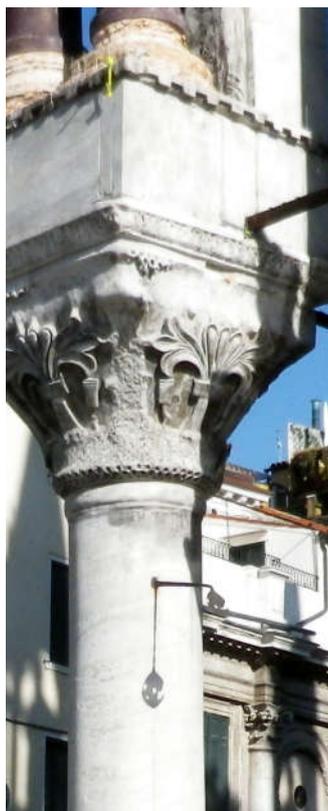
The column of S. Alipio lies at the far NW end of the façade of St Mark's Basilica in Venice.

Although little known and certainly rarely observed, by the multitudes of visitors to this famous place, this column actually supports a noon mark of considerable age.

Whatever, the mark we see today is worn, the gnomon droops and is rusted but the details and engraving of the column are still visible and (with only a little inaccuracy) it still marks Solar Noon today.

Fixed out from the column is a leaf shaped gnomon with a central hole and the rusted remains make three other 'holes' on either side.

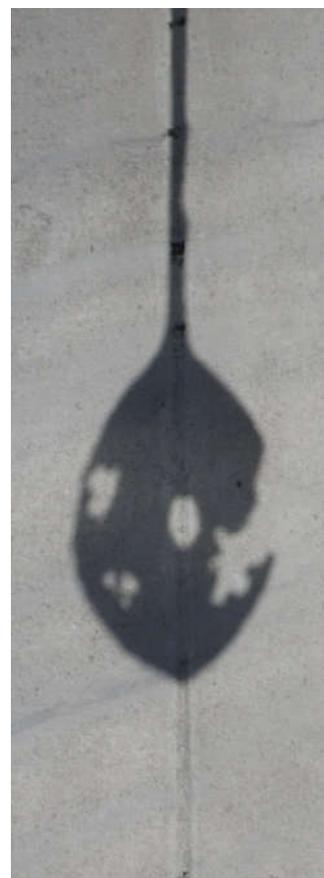
A photograph of the time of the moment of Solar Noon was made at the point shown in the second figure.

Corrections were then made of the reading on the internal clock of the digital camera. The difference from UK time, the daily drift of the camera clock since the photograph had been taken were all considered and the adjustment for Italian time, the longitudinal distance from Venice and the equation of time were all applied. At the end of this the ancient and damaged Noon Mark was found to be showing solar noon only 12m 40 seconds fast!
